Applies To: **2007 Fit** – ALL
2008 Fit – From VIN JHMGD3...8S000001 thru JHMGD3...8S019313

November 30, 2007

Safety Recall: SRS Floor Wire Harness Corrosion

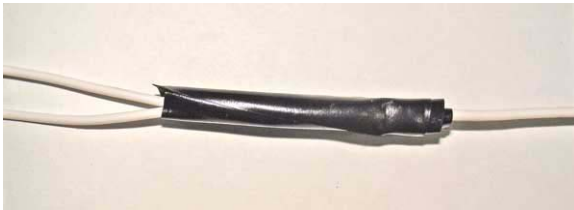
- WHT wire - SRS IG1 circuit
(Two branches)
Applies to both models.

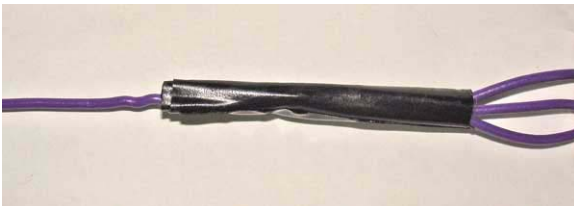
- PUR wire - door switch circuit
(Three branches)
Applies to both models.

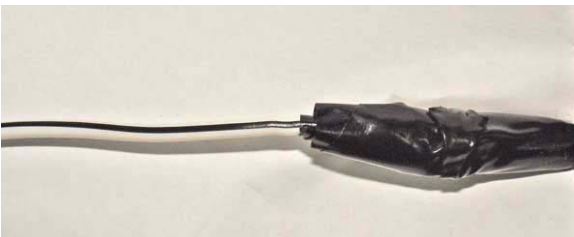
- WHT/BLK wire - door lock motor circuit
(Two branches)
Applies to both models.

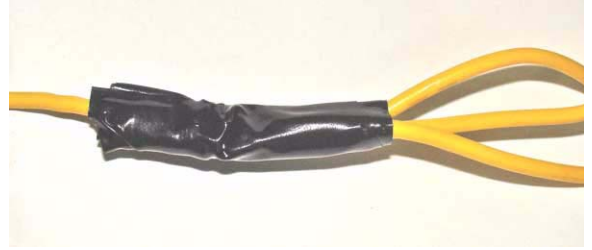
- YEL wire - door unlock motor circuit
(Three branches)
Applies to both models.

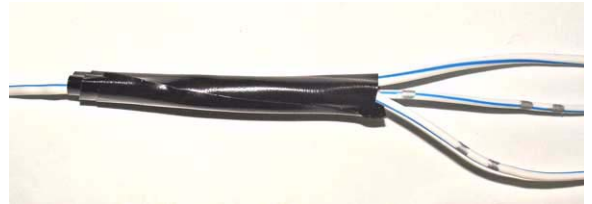
- WHT/BLU wire - security system circuit
(Three branches)
Applies to Sport model only.
